UNPACKING VIBRATION ANALYSIS - a case study

By Reinier Kalp*
WearCheck technician: Asset Reliability Care

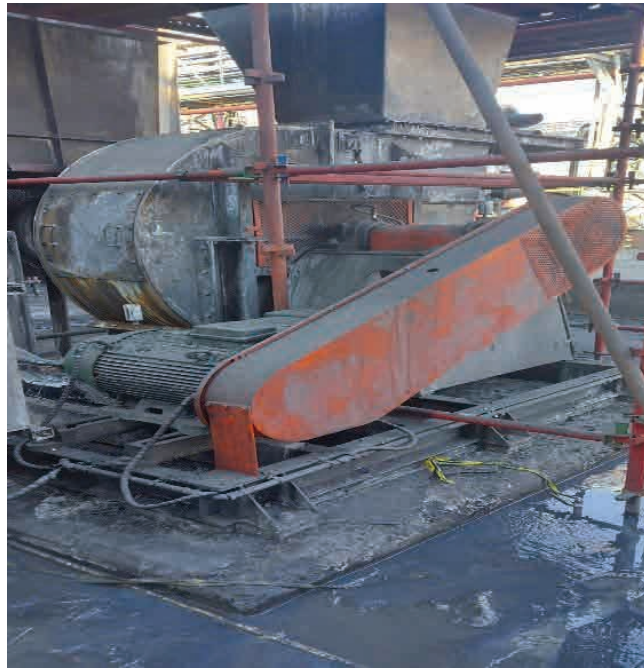
During routine vibration data collection on a Boiler ID fan, it was noticed that severe structural vibration was emanating from the unit. Upon further visual inspection it was apparent that most of the base bolts were loose or completely missing. A request was raised by WearCheck to the relevant mechanical workshop to inspect the machine base of the Boiler ID fan and fasten/replace all bolts as required. This Technical Bulletin demonstrates the usefulness and accuracy of condition monitoring applications on a plant.

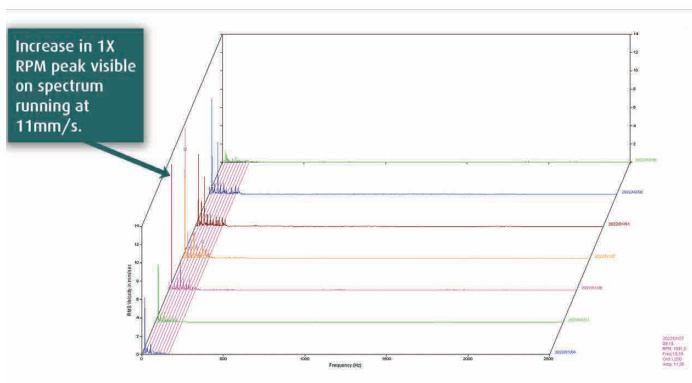
Below is an image of the vibration data from the Boiler ID fan. As can be seen in the graph, there was a clear increase in amplitude of the 1X RPM peak on the spectrum. Our visual inspection of the unit can now confirm the vibration we are seeing on the graph. The loose/missing bolts will definitely be a contributing factor towards the increase in amplitude of the 1X RPM peak.

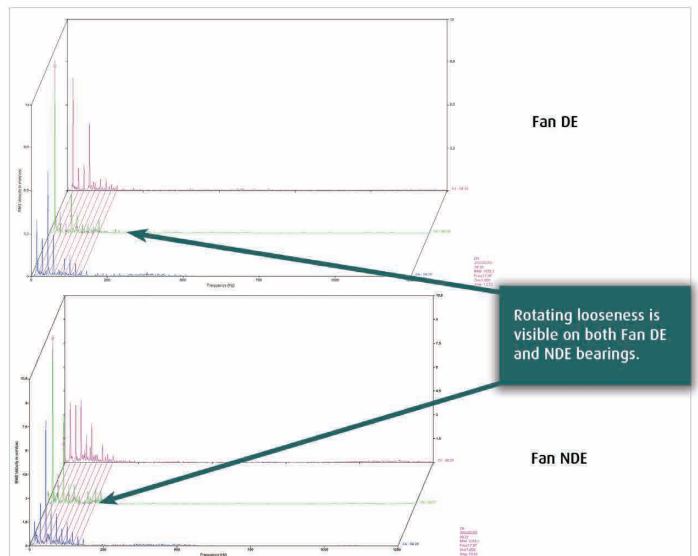
Below is another image of the vibration data that was captured from the Boiler ID fan. In this image, it is evident that secondary damage has occurred to the fan bearings and thus we are now detecting rotating looseness due to bearing wear that was initially instigated by the structural looseness.

Information about this defect was conveyed to the relevant department, and it was then decided that they would be changing out the fan DE and NDE bearings. After the fan bearings and pulleys were swapped out, WearCheck was requested to do a pulley alignment.

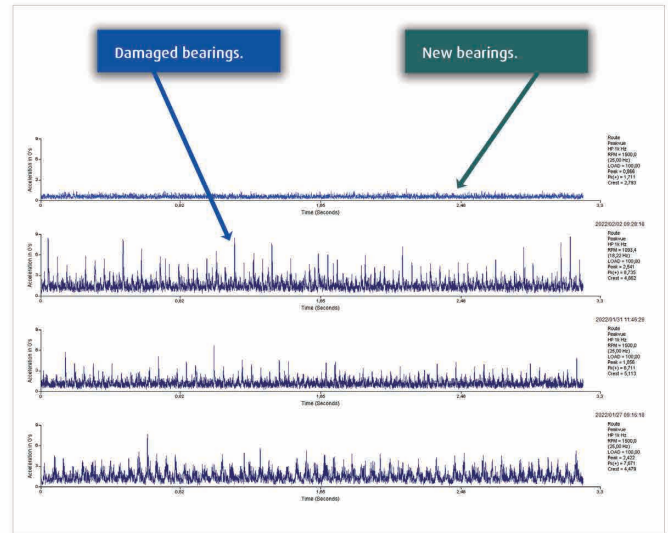
After the alignment was completed, another set of vibration readings was taken on the Boiler ID fan. In the following image, it is clear that the bearing damage that was previously visible on the old bearings, is no longer present, which is to be expected seeing that the fan is now running with a new set.

Unfortunately, after all this work was completed, we still had a problem of a high 1X RPM that was present on the vibration spectrum. This can now only mean one thing - we have an unbalance condition on the fan.

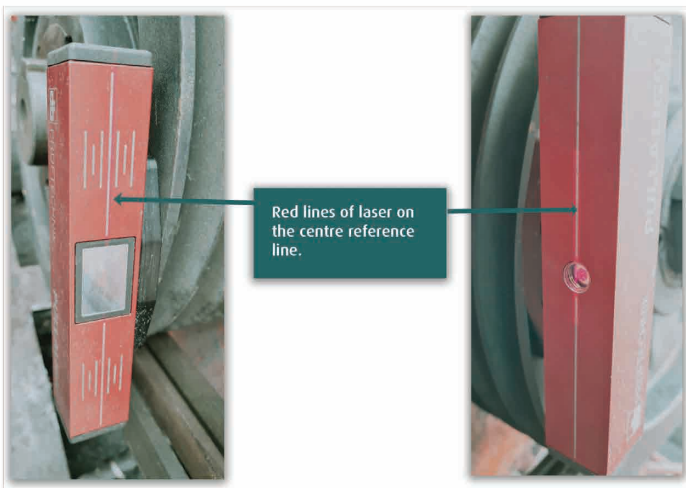
The following images show the pulley alignment tools after the alignment was completed on the Boiler ID fan, indicating that the alignment was in spec.

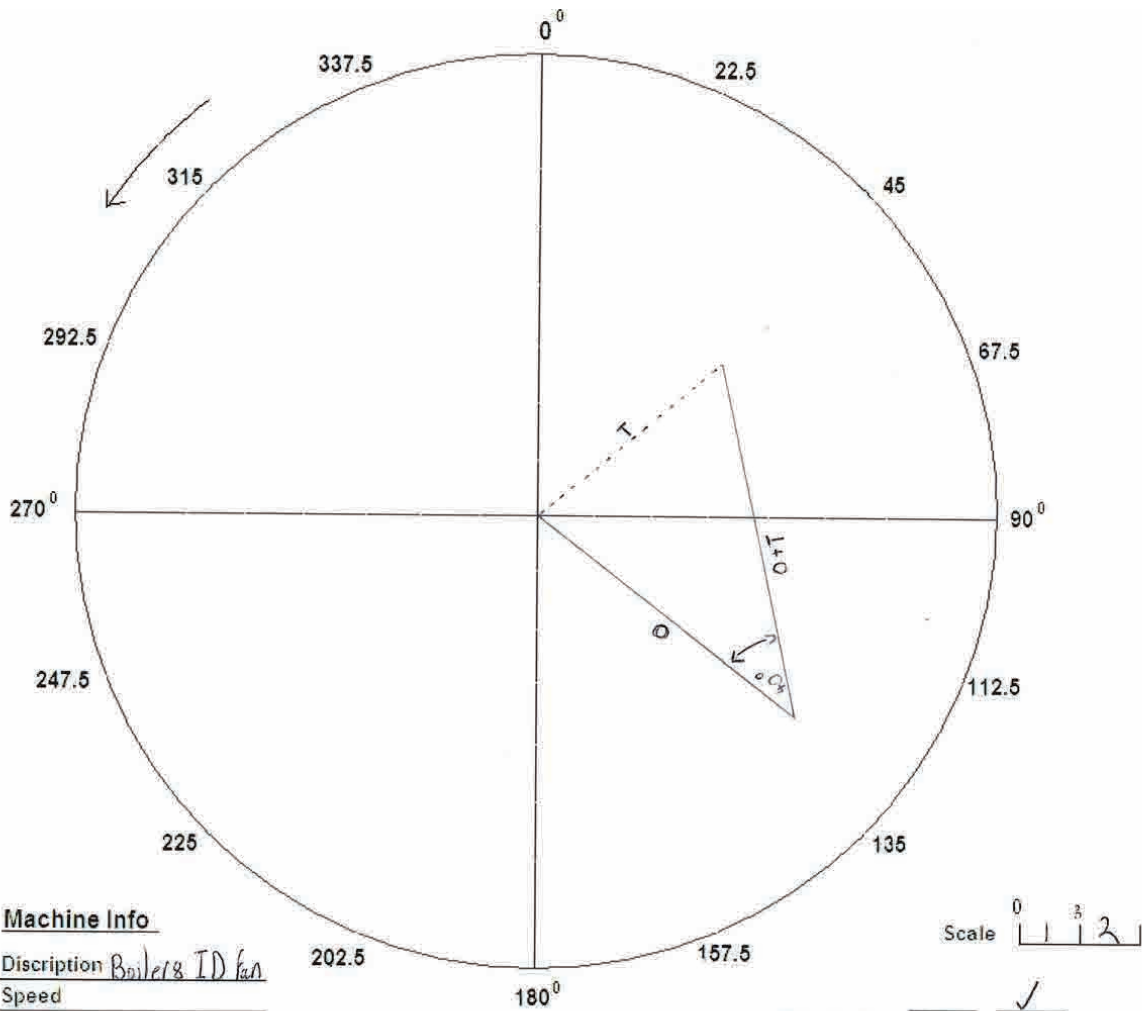
Below is a vector diagram that is drawn in the field while the balancing job is taking place. We plot the data collected from the vibration data logger on the vector diagram to calculate the final correction weight, as well as the location of where the said weight must be applied.

1. With an accelerometer and tacho connected to the vibration data collector, take an initial reading on the machine. This data will be presented as a velocity reading in mm/s as well as a phase reading presented in degrees. Our initial reading on the Boiler ID fan was 11mm/s @ 128 degrees.
2. The next step is to add a trial weight to the fan impeller to force an increase/decrease in vibration amplitude and then take another set of data. We then added a trial weight of 115grams to the impeller and got a reaction of 8mm/s @ 50 degrees.
3. With this information at hand, we were then able to calculate the appropriate mass needed to counteract the unbalance force as well as where exactly to put it on the impeller. We then calculated that the impeller needed a correction weight of 104 grams @ 320 degrees.

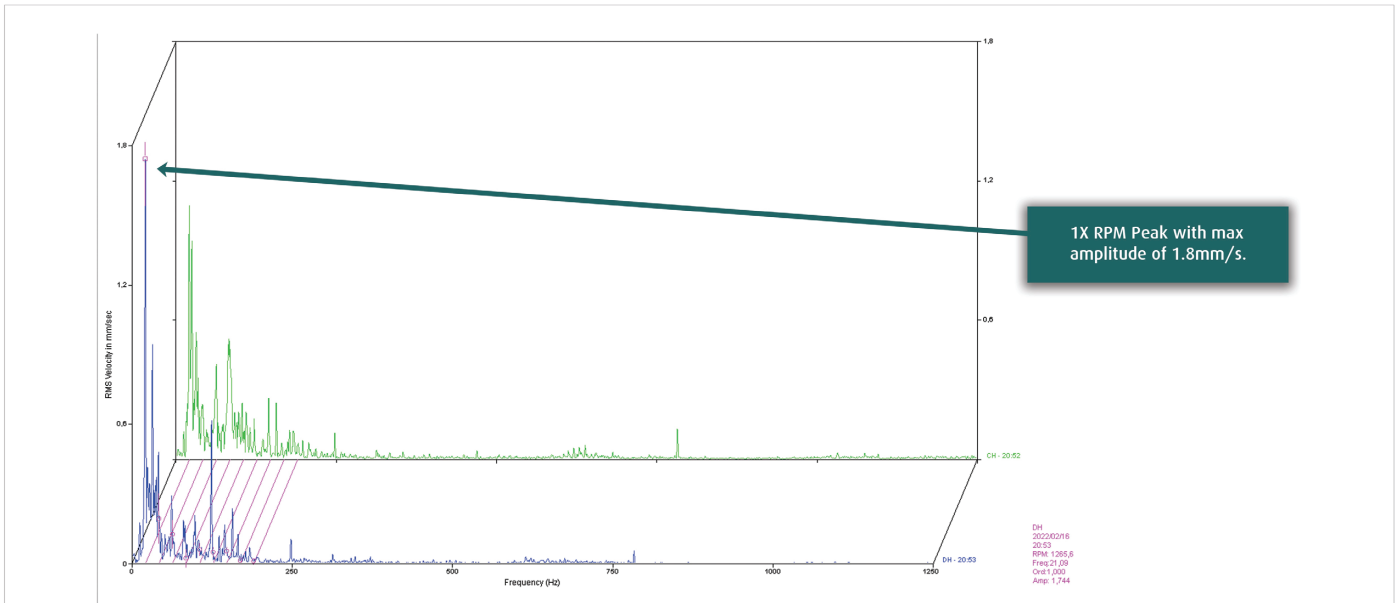
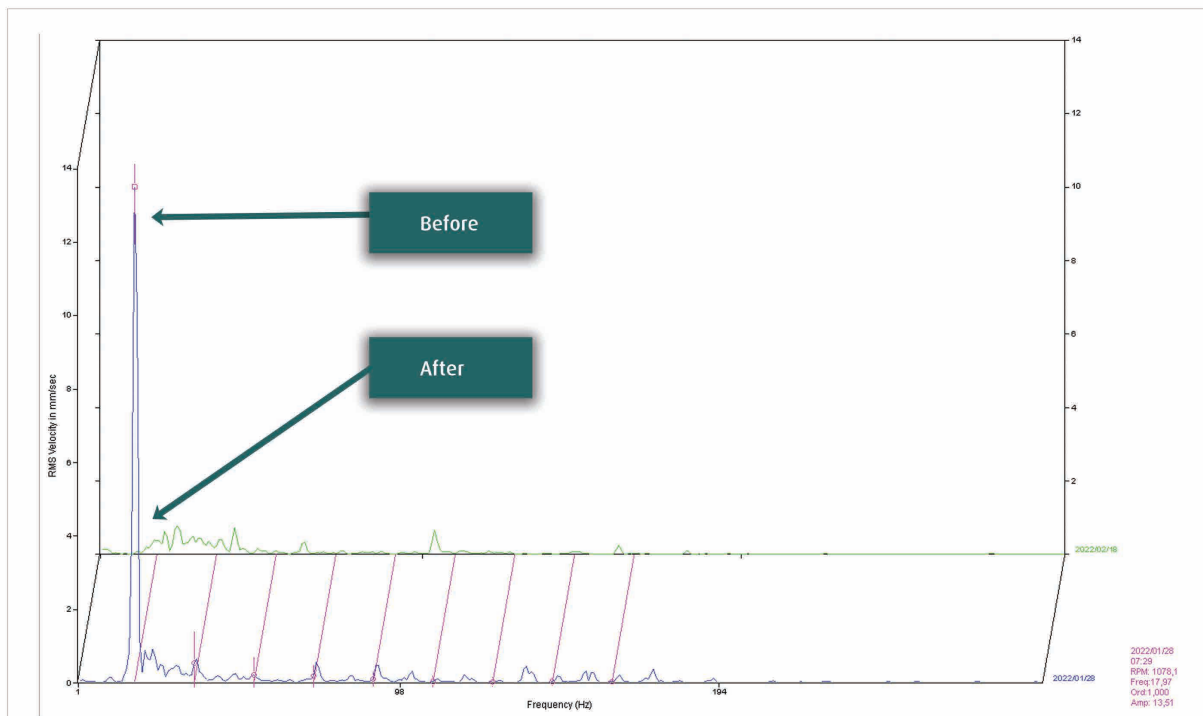
In the above image one can see the latest data taken on the Boiler ID fan DE & NDE bearings. The spectrum clearly shows a dramatic decrease of the fan 1X RPM peak, which is now at 1.8mm/s- a big improvement on the initial reading of 11mm/s. This case study demonstrates yet another way that condition monitoring can impact and improve machine reliability on your plant.
