Detailed Morphological Wear Particle Analysis

Analytical Ferrography

ANALYTICAL FERROGRAPHY GOES BEYOND THE TYPICAL PART PER MILLION WEAR ANALYSIS OF TRADITIONAL OIL ANALYSIS PROVIDING YOU WITH A DETAILED MORPHOLOGICAL ANALYSIS OF THE WEAR MODE OF YOUR EQUIPMENT.

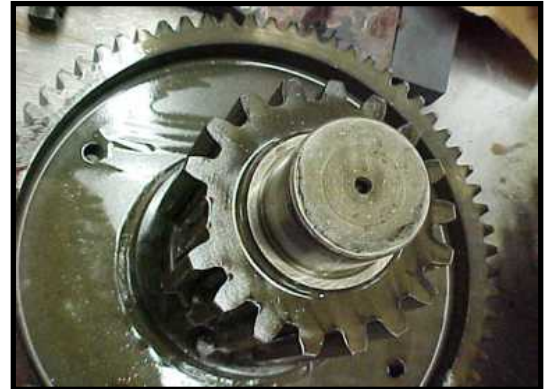
Automotive Manufacturing – Assembly Line Gearbox **Cost: \$15,000,000**

Aside from the analytical ferrography, no other tests indicated any abnormality with this oil sample. The A-Ferr, however, clearly showed severe gear wear, and indicated wear at the gear tooth root. This A-Ferr indicated that a catastrophic failure was imminent.

Although the A-Ferr clearly indicated that this unit was going to suffer a catastrophic failure, a maintenance decision was made to do a planned replacement of another assembly line gearbox. The result, the entire plant was shut-down for 12 hours due to this unscheduled failure.
