UNPACKING VIBRATION ANALYSIS - a case study

By Reinier Kalp*
WearCheck technician: Asset Reliability Care

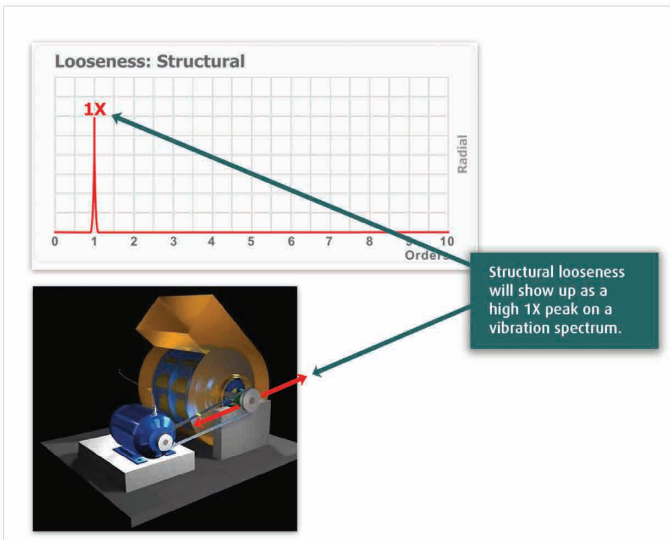
Structural looseness is caused by a weakness in the foundation (e.g., cracks in concrete or, in this particular situation, the loose/missing bolts). This weakness allows the machine to vibrate more freely in the direction where the weakness is greatest and therefore vibration at turning speed, or 1X as we like to call it, will be elevated.

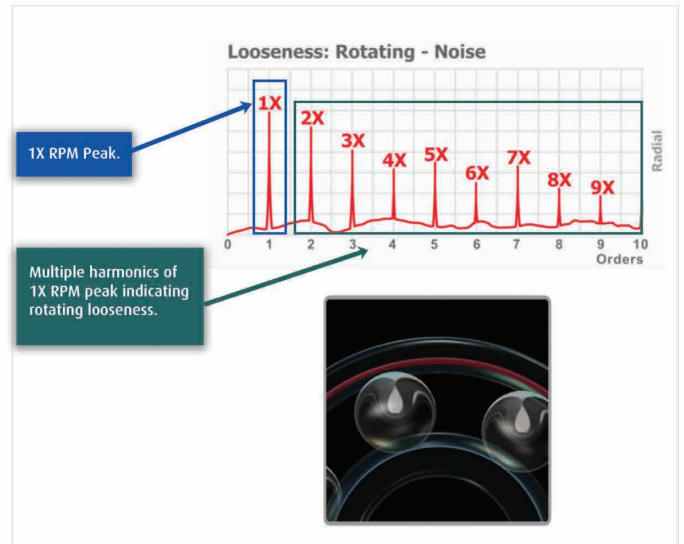
This increase in vibration is always dangerous as this can cause secondary damage to other components of the machine. In this particular case, another defect started to develop, called rotating looseness. Clearance in journal and rolling element bearings will produce harmonics of the 1X peak and will start to occur when there is bearing damage present.

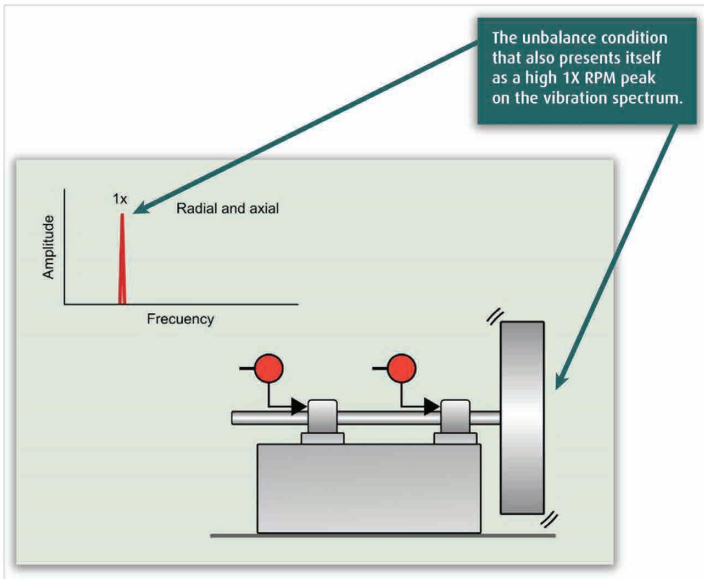
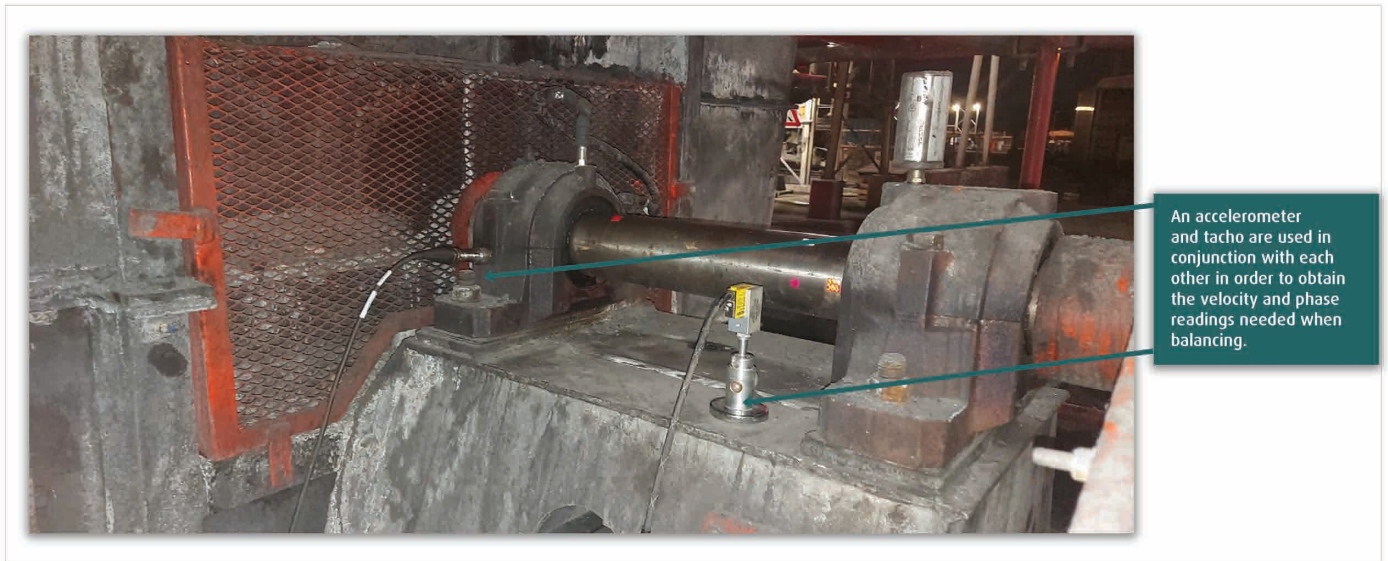
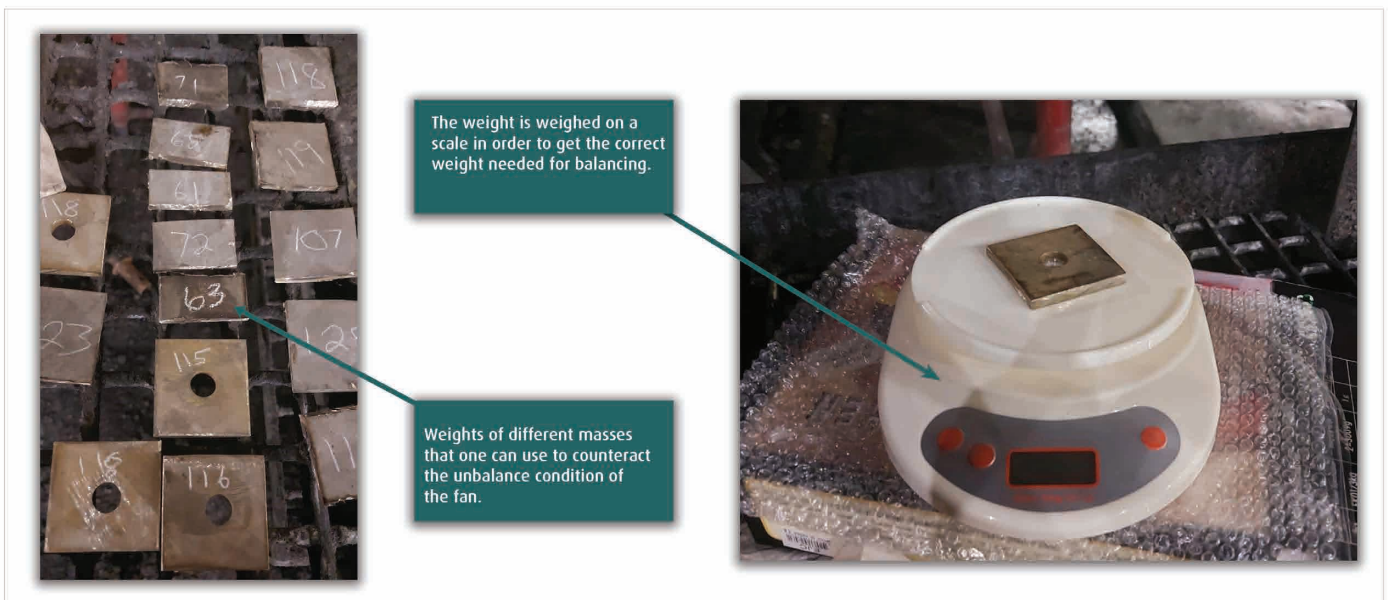
1. With an accelerometer and tacho connected to the vibration data collector, take an initial reading on the machine. This data will be presented as a velocity reading in mm/s as well as a phase reading presented in degrees. Our initial reading on the Boiler ID fan was 11mm/s @ 128 degrees.
2. The next step is to add a trial weight to the fan impeller to force an increase/decrease in vibration amplitude and then take another set of data. We then added a trial weight of 115grams to the impeller and got a reaction of 8mm/s @ 50 degrees.
3. With this information at hand, we were then able to calculate the appropriate mass needed to counteract the unbalance force as well as where exactly to put it on the impeller. We then calculated that the impeller needed a correction weight of 104 grams @ 320 degrees.
